# Inspection Report

**Jon and Jane Doe**

123 Sample St  
Atlanta GA

**TorchLight Home Inspections**

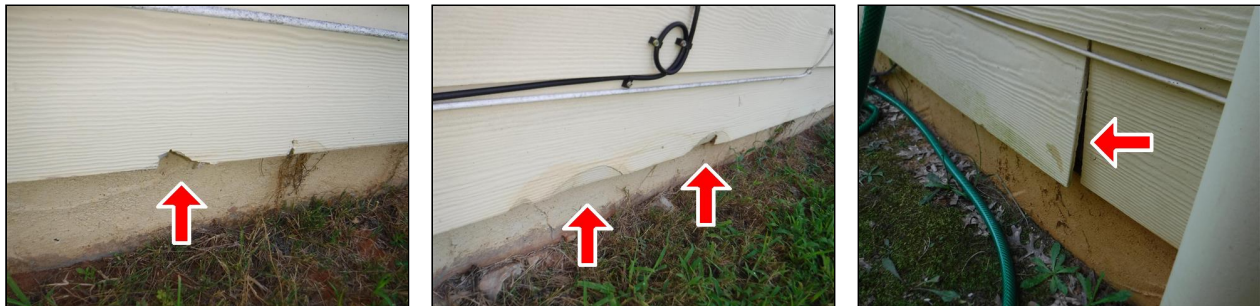
- (1)
- The bottom run of cement board siding at the rear of the home and left side (facing front) is damaged or loose in areas. This is a minor repair item. A qualified person should repair or replace as needed.

Damage at right side of home

Damage at rear of home

Loose board at right side of home

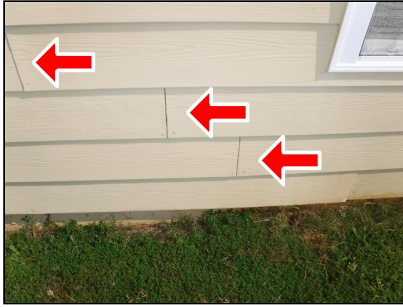
- (2)
- The Cement board siding at the exterior in areas is not sealed at the butt joints. Unsealed joints can allow water to enter behind siding or wall cavity and more damage could result. A qualified person should repair or replace as needed. A qualified person should repair(seal) as needed.

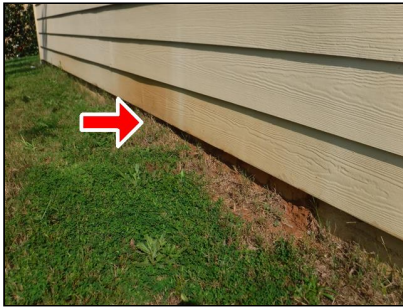
(3)

- Siding is in contact with grade at the left side (facing front). Because the siding is in contact with ground it is possible for the siding to be deteriorated and the framing to be damaged via moisture wicking. Recommend a ground clearance of six inches at soft grade and 2 inches at hard grade where possible per manufacture installation instructions and current building code guidelines.

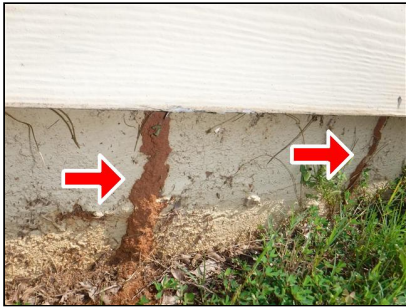
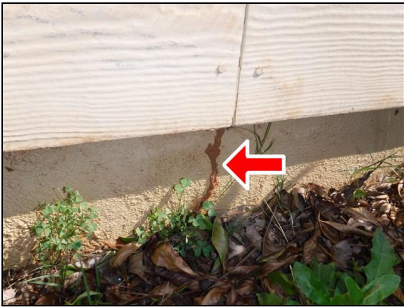
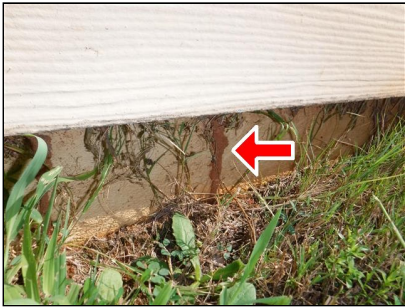
- There is evidence of an active termite infestation that was observed on the poured concrete slab at the left side of the home. Termites can cause damage to structure and components. A pest control company should inspect further and treat as needed.

Termite mud tubes

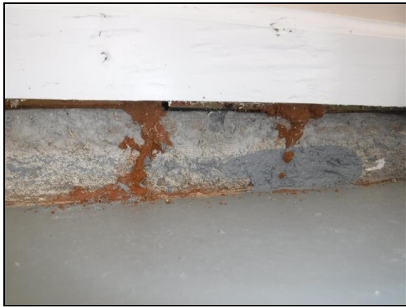
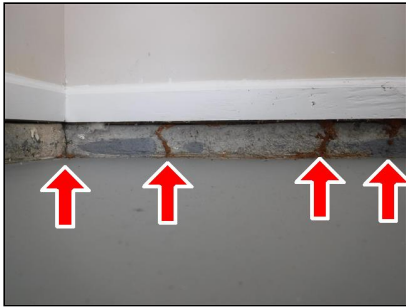
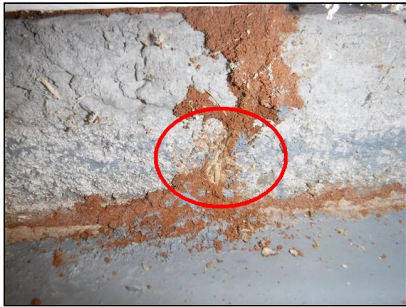
- There is evidence of an active termite infestation that was observed at the garage. Termites can cause damage to structure and components . A pest control company should inspect further and treat as needed.

Termite mud tubes

Active termites

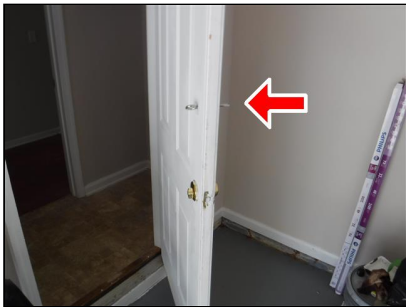
- The garage entry door only has a dead bolt and does not have a knob. A repair or replacement is needed. A qualified person should repair or replace as needed.

No door knob/handle

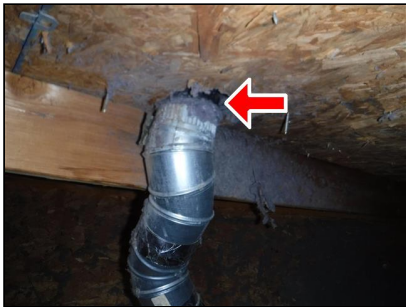
- 5.0 Insulation in Attic
- Comments: Acceptable
- 5.4 Ventilation of Attic and Foundation Areas
- Comments: Acceptable
- 5.5 Venting Systems (Kitchens, Baths and Laundry)
- The dryer vent piping is loose, is not connected in the attic at the roof penetration. Vent pipes should be cleaned regularly if they are longer than normal ( 10 feet or more) or vented vertically

Excess lint in the dryer vent is considered a fire hazard as the dry lint material is very flammable. A qualified person should repair or replacement as needed.

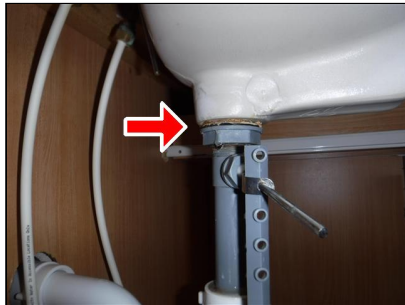
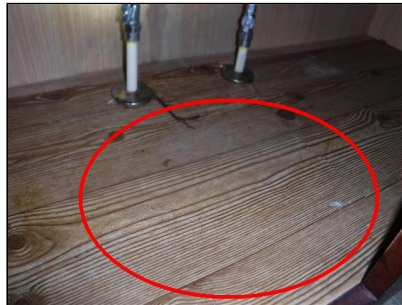
- The plumbing waste line leaks (under sink) at the Upstairs Bath sink. Repairs are needed to stop leaking water from damaging the cabinet bottom or to eliminate moisture that may contribute to fungi growth. A qualified person, or a qualified plumbing contractor should inspect further and repair or replace as needed.

Leaks at drain

Water puddle

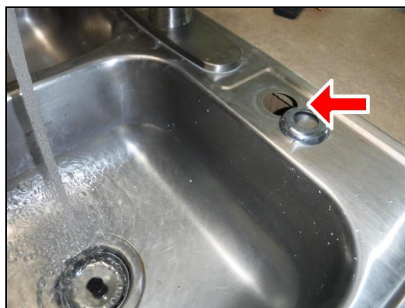
- The the soap dispenser is missing at the kitchen sink. A qualified person should replace as needed.

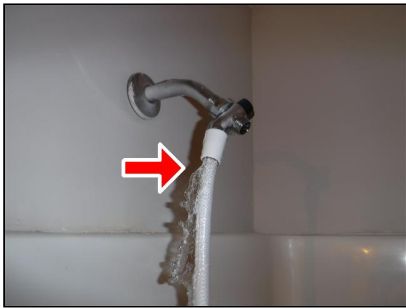
- (3)
- The shower head is damaged and leaks at the connection at the Upper Level bathroom. Repairs are needed A qualified person should repair or replace as needed.

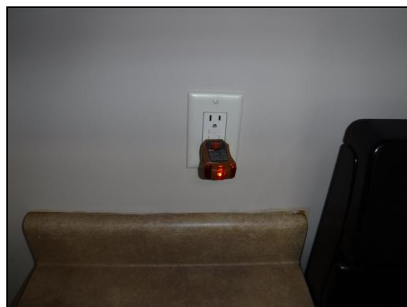
- The GFCI outlet at the Kitchen(left of oven) is a non-grounded outlet which is currently acceptable, however, it should be labeled a non-grounded GFCI and it is not as safe as a grounded GFCI (for your information).

Open ground

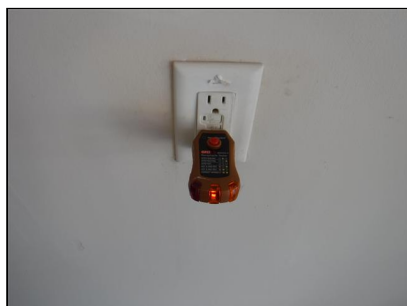
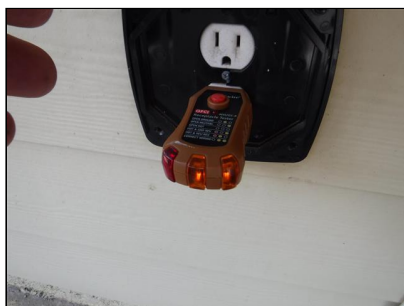
- All the GFCI (Ground Fault Circuit Interrupter) outlets at the garage and exterior wont "trip" when tested. Electrical issues are considered a hazard until repaired. A qualified person or qualified licensed electrical contractor should correct as needed.

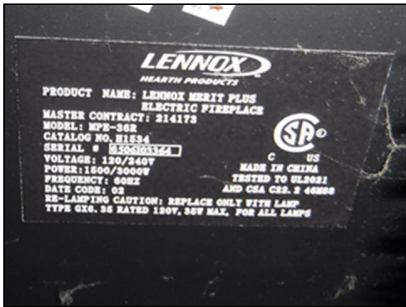
- We attempted to operate the electric fireplace insert but were not successful. Recommend consult current owner or a service technician for proper operation of fireplace.

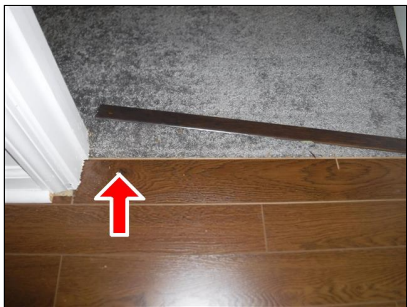
- The transitional moulding at the Kitchen and Master Bedroom is loose. This is a small repair issue for your information. A qualified person should repair or replace as needed.

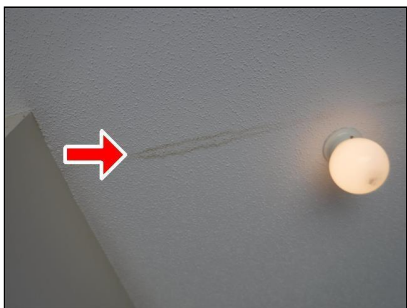
- The Sheetrock on the ceiling at the garage and upstairs bedroom reveals a light stain which appears from a water leak. Stain appears old. A moisture meter was used and readings at the "wet area" were consistent with readings at the "dry area" indicating the leak did not exist on the day of the inspection. This is a cosmetic issue and is for your information.

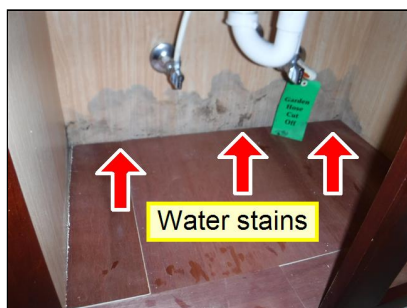
- (1)
  - All cabinet doors and drawers were opened and all function as intended unless otherwise noted in this report.
- (2)
  - The cabinet rear panel in Master Bath shows evidence of water stains and the base has been replaced. This is a cosmetic issue for your information. I recommend repair (prep, prime, and paint) as desired.

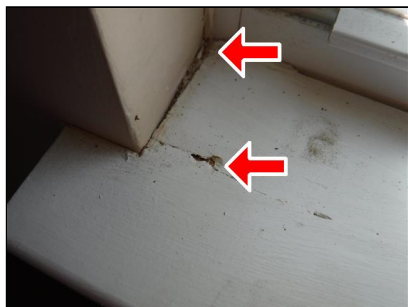
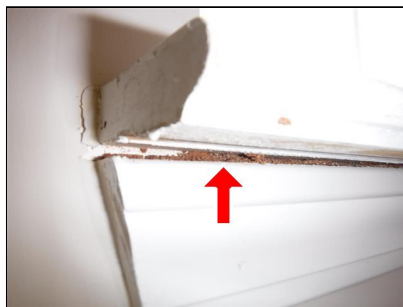
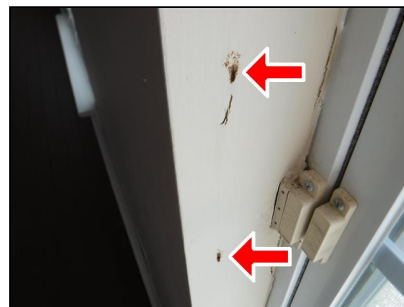
- (1)
  - All accessible windows tested successfully for function and safety (locking) features unless otherwise noted in this report.
- (2)
  - There is evidence of an active termite infestation that was observed at the window framing in the living room. Termites can cause damage to structure and components. A pest control company should inspect further and treat as needed.

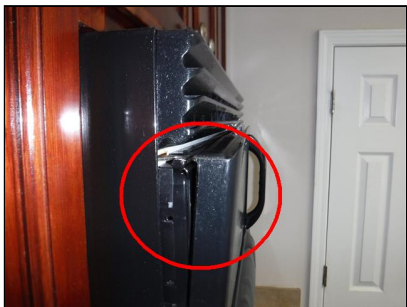
- The microwave door is broken and does not shut properly. I recommend further review by a qualified appliance service technician and repair or replace as necessary.

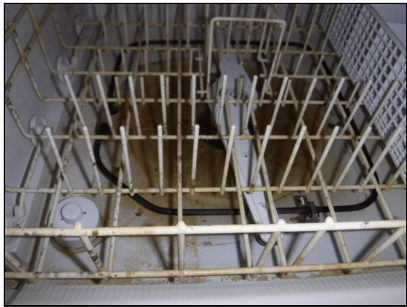
- The dishwasher is dirty and did not complete normal cycle. I recommend further review by a qualified appliance service technician and repair or replace as necessary.
