# Inspection Report

**Jon and Jane Doe**

123 Sample St  
Atlanta GA

**TorchLight Home Inspections**

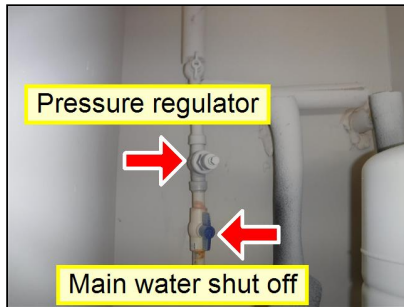
- The main shut off is the knob located in the garage behind the water heater. This is for your information.
- The pressure regulator is located in the garage above the main water shut off valve.

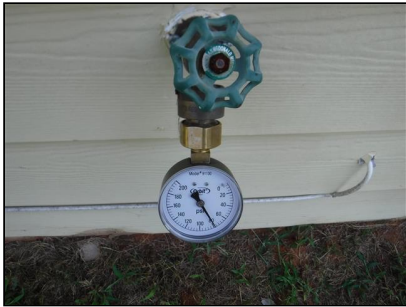
Left side hose bib

- The water pressure over-all is good and pass "functional flow". Which is determined by running water in the sink and shower while toilet is flushed. If shower spray remains, it passes.
- The water pressure at the exterior hose bib registered 79 psi. Normal operating pressure should be from 40 psi to 80 psi.

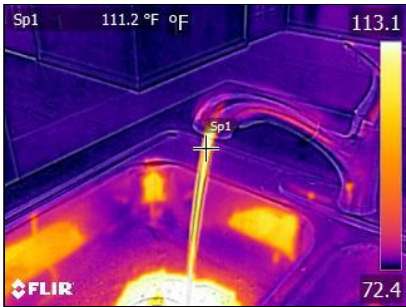
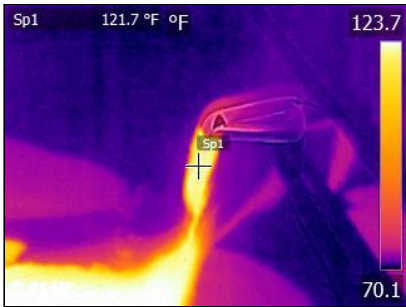
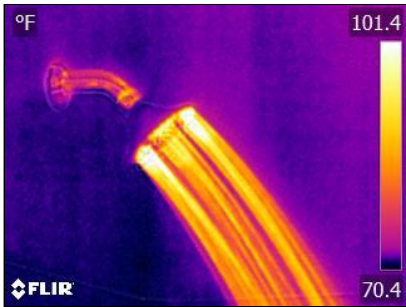
- This water heater is 12 years old and at the end of its life expectancy.
- (2)
- The hot water line at the kitchen sink tested 111.2°F.
  - The hot water line at the bathrooms tested up to 121.7°F.

- Recommended temperature for the kitchen sink for sanitary reasons is 115-120°F.
  - Maximum recommended temperature for the bathroom sink, shower, and tub is 120°F to prevent scalding.

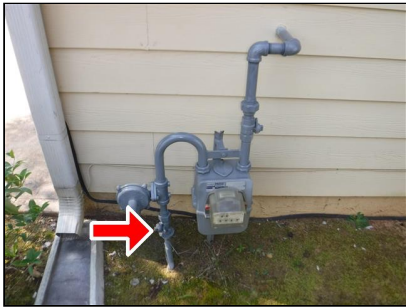
Main gas shut off

- The main fuel shut off is at the gas meter outside on the right side (facing front) of the house.

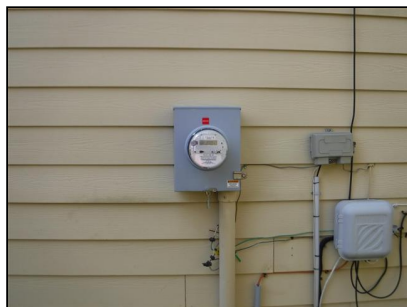
- Electric meter is located at the right side of the home.

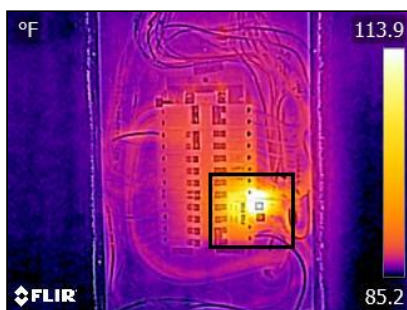
AFCI Breakers

- All AFCI breakers were successfully tested unless otherwise noted in this report. AFCI breakers always operate "hotter" than a typical breaker due to the nature of the unit(constant current flow). This is evident in the thermal image of the distribution panel.

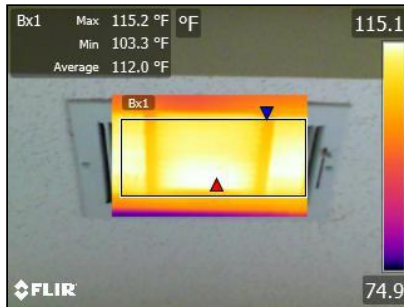
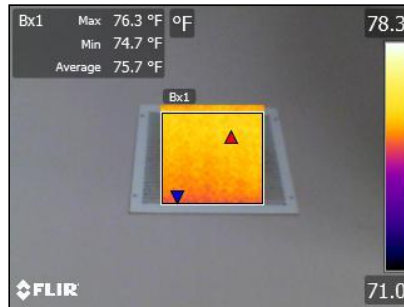
- The heat system was tested in normal mode and operates as intended. Within the first minute(s) of operation, the supply air temperature at the distribution register read 112.0°F and the temperature at the return register read 75.7°F. This indicates the heating system is operating as intended

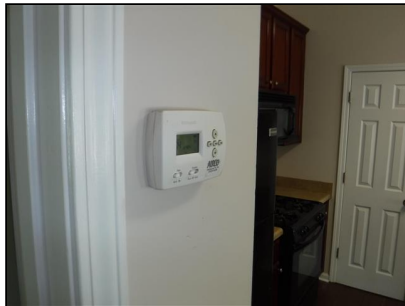
- The thermostat is located on the wall in the kitchen and on the wall of the upper level loft area.

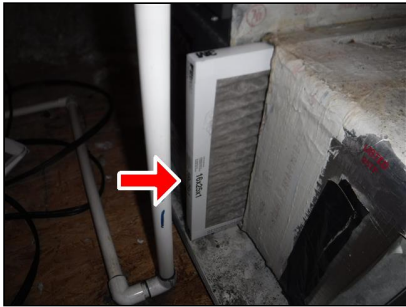
Filter size 16x25

- Recommend installation of new filter upon taking occupancy of home.
- Recommend replacement of filter 30 days after occupancy of home.
- Recommend replacement of filter every three months or per HVAC Service Contractor recommendations.
- The filter is located at the furnace located in the attic.
- Recommend placing the date installed on each new filter as it is installed.

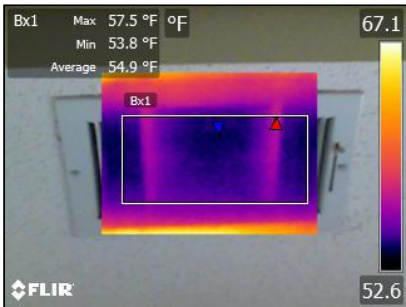
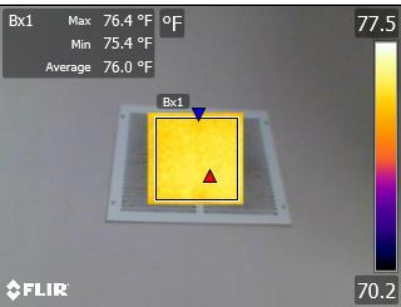
- (1)
- Recommend service/maintenance of HVAC cooling system in the spring prior to first use.
  - Based upon information from the Air Conditioning and Refrigeration Institute, and other industry sources, the life expectancy for a central air conditioner or the compressor for a central air conditioner is 14-16 years as a guideline.
  - This unit is 12 years old. Manufactured in November 2006.
- (2)
- The ambient air test was performed by using thermometers on the air registers of the main level heat pump in cool mode to determine if the difference in temperatures of the supply and return air are between 14 degrees and 22 degrees which indicates that the unit is cooling as intended. The supply air temperature on your system read 54.9 degrees, and the return air temperature was 76.0 degrees. This indicates the range in temperature drop is normal.

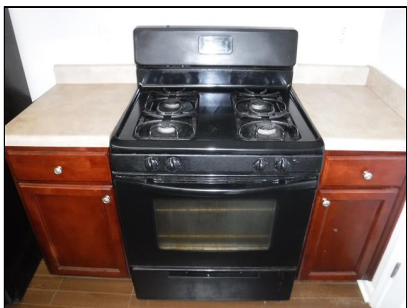
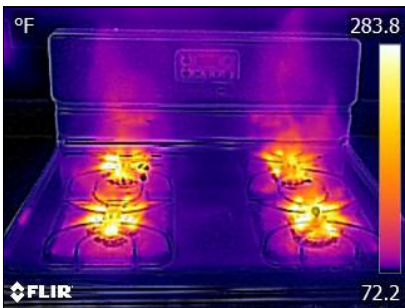
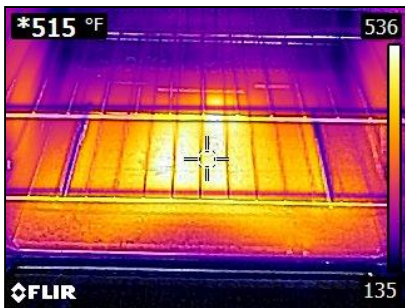
11.2 Ranges/Ovens/Cooktops

- The stove top and the oven were tested and function as intended.

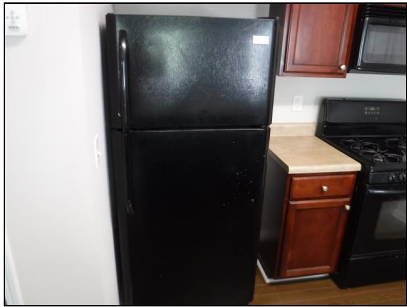
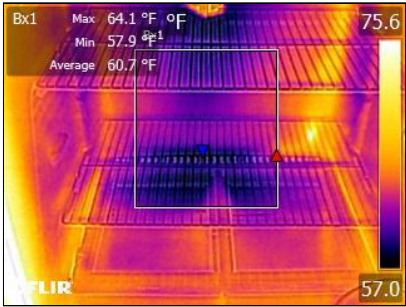
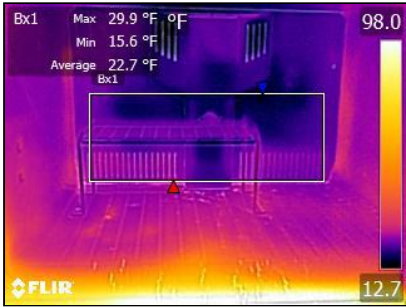
11.3 Refrigerator

- The measured temperature in the refrigerator was 60.7°F.
- The measured temperature in the freezer portion was 22.7°F.
- Optimum temperature range for a refrigerator is 35°F to 38°F.
- Optimum temperature range for a freezer is 0°F to -10°F.
- (The fridge was not plugged in at the start of the inspection and was only operated for the duration of the inspection)

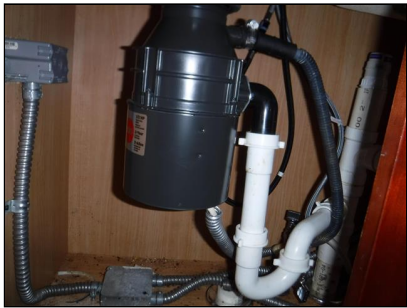
11.5 Food Waste Disposer

- The food disposer was operated and the blades turned as intended and the unit did not leak.
